# UNDERWATER INSPECTION REPORT

Quinsippi Island Bridge  
Over the Mississippi River  
Near Quincy, IL

Inspection Date: October 8, 2015

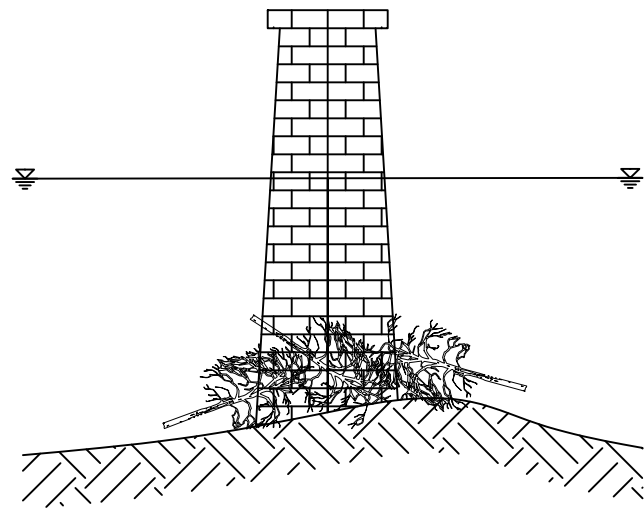
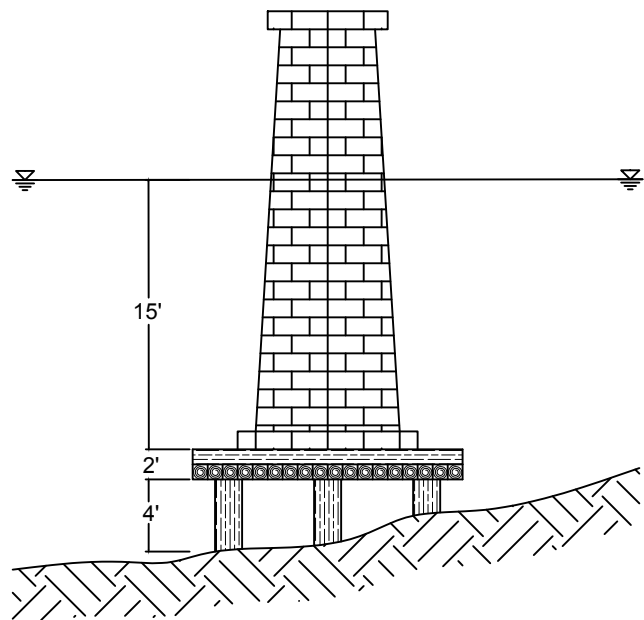
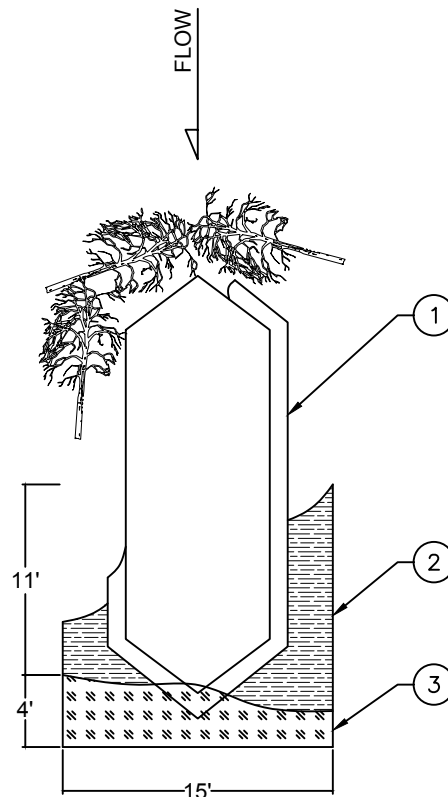
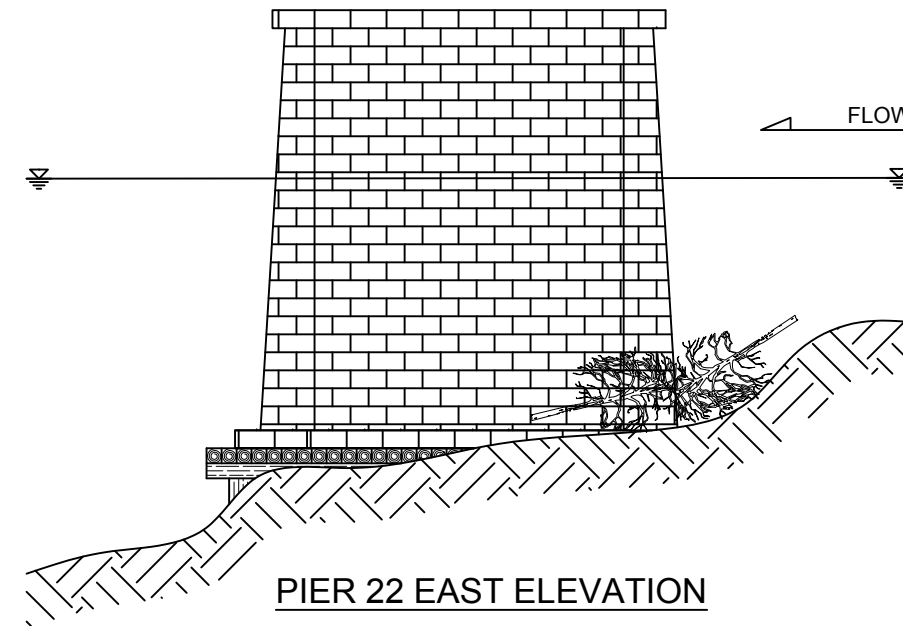
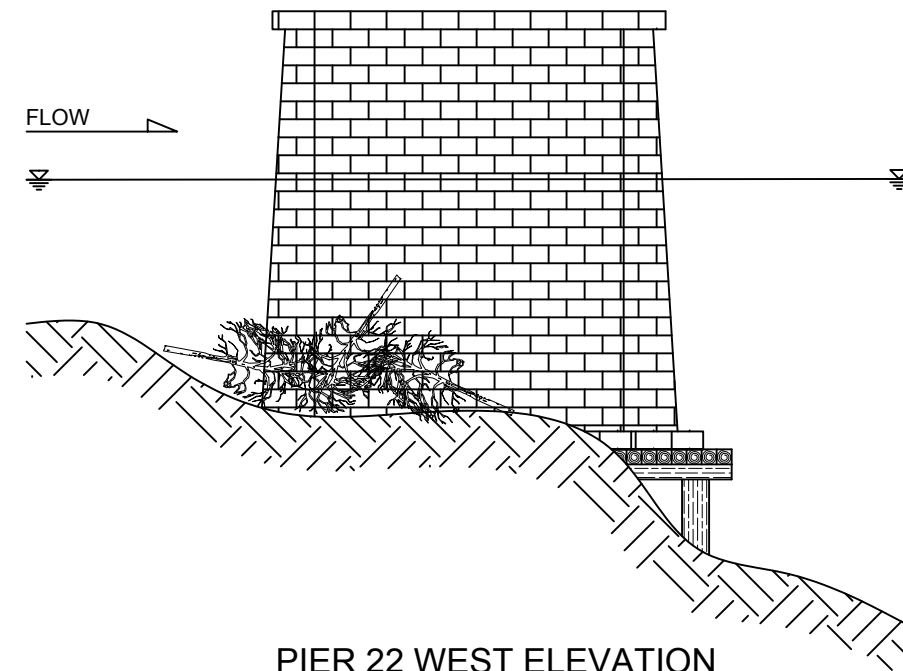
1. EXPOSED MASONRY STONE PIER FOOTING.
2. EXPOSED TIMBER CRIBBING. ALL OF THE EXPOSED TIMBER APPEARED TO BE IN SOUND CONDITION WITH NO INDICATION OF SPLITTING OR ROTTING.
3. UNDERMINING BENEATH THE TIMBER CRIBBING ON THE DOWNSTREAM SIDE OF THE PIER EXPOSING SEVERAL VERTICAL TIMBER PILES. THE UNDERMINING EXTENDED APPROXIMATELY FOUR (4) FEET ALONG THE WEST FACE OF THE PIER AND APPROXIMATELY TWO (2) FEET ALONG THE EAST FACE.

Brennan recommends that the undermining of Pier 22 be repaired in order to return full load bearing capacity to the structure. Scour countermeasures should then be placed around the structure in order to protect the pier from further scour potential. The soft bottom substrate should be taken into account when evaluating any scour countermeasures as some of that material may need to be removed in order to prevent the countermeasure devices themselves becoming undermined. Due to the high susceptibility of the bottom substrate to scour, Brennan also recommends placing scour countermeasures around the other in-water piers before the scour and undermining has the chance to develop in those areas.

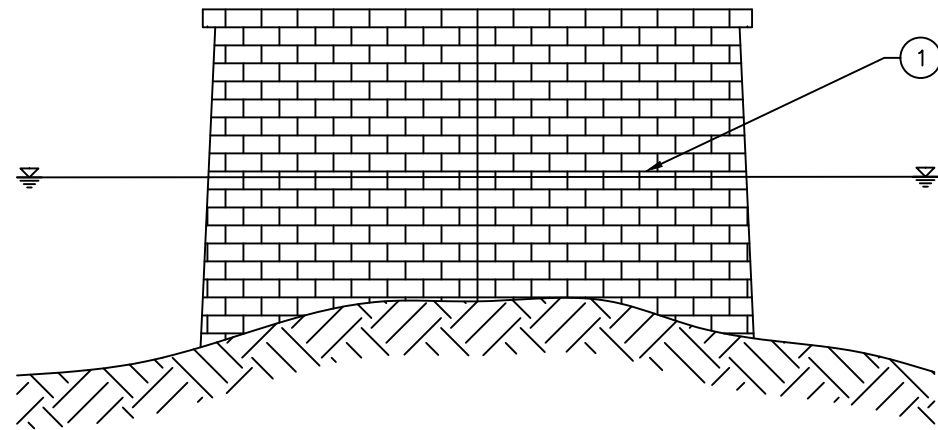
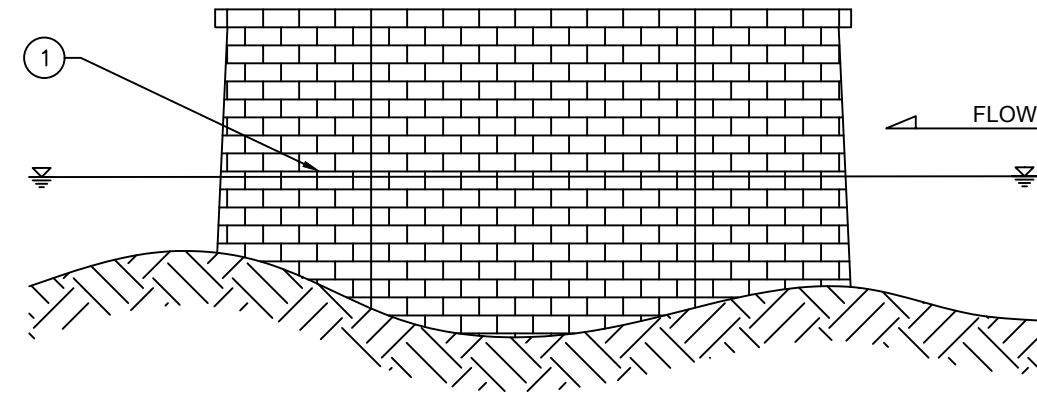
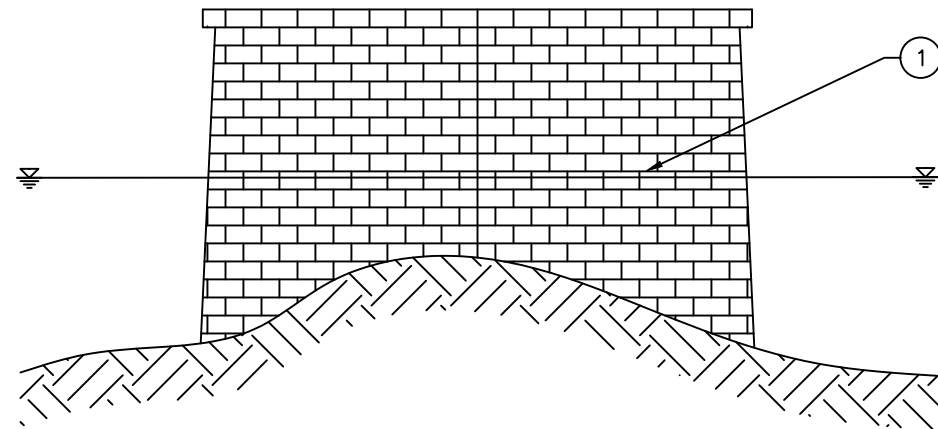
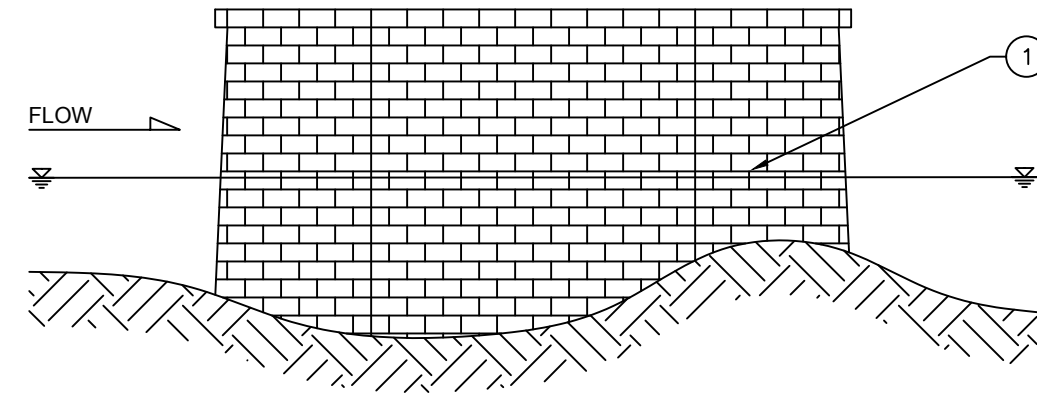
PROJECT:  
**UNDERWATER INSPECTION REPORT**  
**QUINCY ISLAND BRIDGE**  
 QUINCY, ILLINOIS  
**PIER 23 ELEVATION**

1. MODERATE MORTAR JOINT LOSS WAS LOCATED WITHIN THE FREEZE-THAW ZONE AROUND THE PERIMETER OF THE PIER. ADDITIONAL AREAS OF STONE LOSS AND MINOR CRACKING WITHIN INDIVIDUAL STONES WAS PRESENT SURROUNDING THE WATERLINE AS WELL.

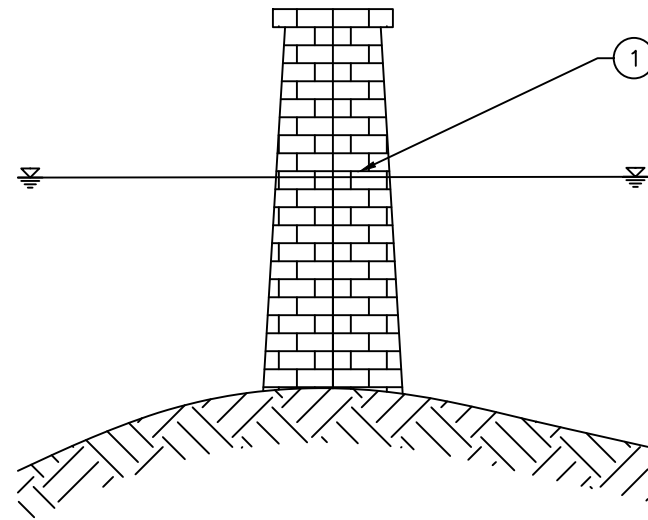
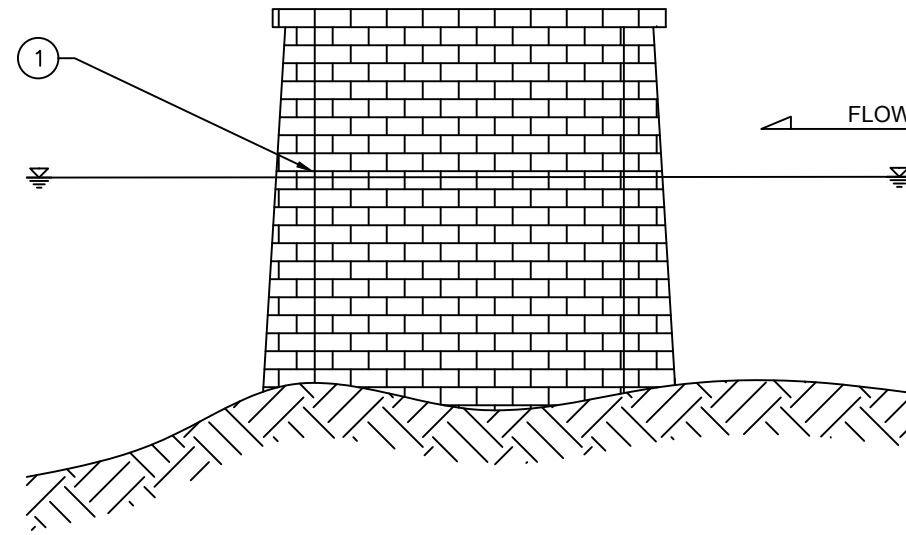
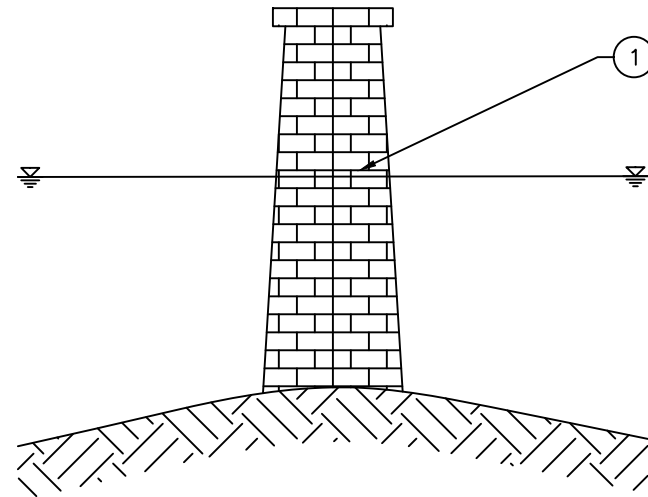
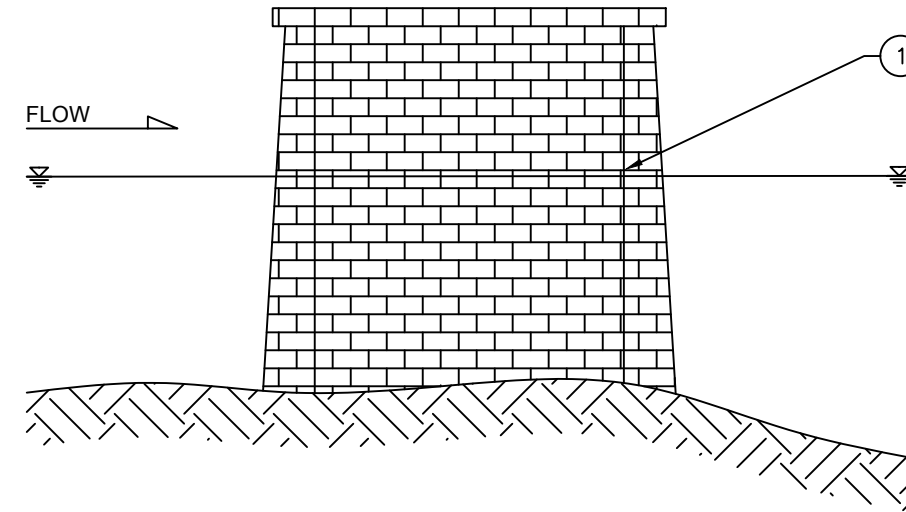
PROJECT:  
**UNDERWATER INSPECTION REPORT**  
**QUINCY ISLAND BRIDGE**  
 QUINCY, ILLINOIS  
**PIER 24 ELEVATION**

1. MODERATE MORTAR JOINT LOSS WAS LOCATED WITHIN THE FREEZE-THAW ZONE AROUND THE PERIMETER OF THE PIER. ADDITIONAL AREAS OF STONE LOSS AND MINOR CRACKING WITHIN INDIVIDUAL STONES WAS PRESENT SURROUNDING THE WATERLINE AS WELL.

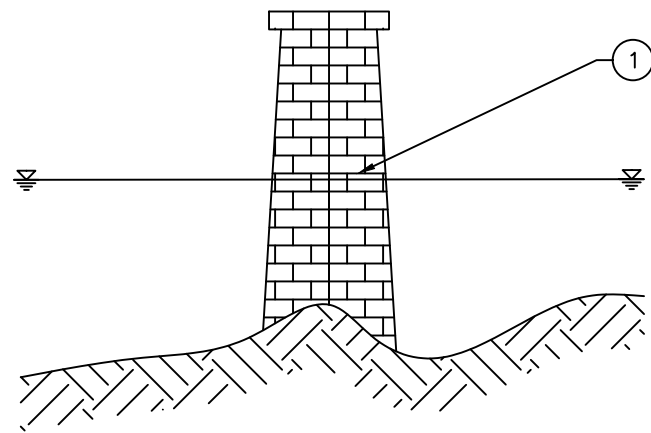
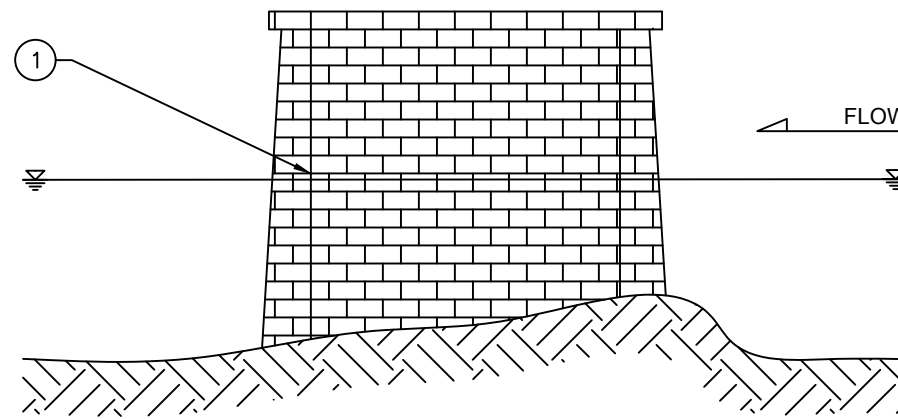
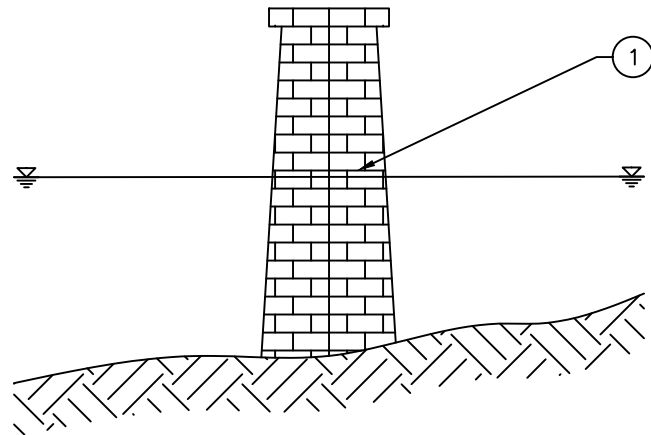
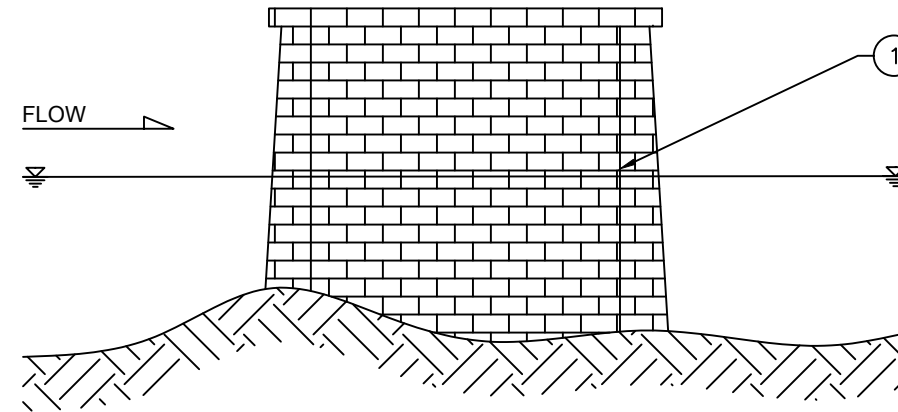
PROJECT:  
**UNDERWATER INSPECTION REPORT**  
**QUINCY ISLAND BRIDGE**  
 QUINCY, ILLINOIS  
**PIER 25 ELEVATION**

1. MODERATE MORTAR JOINT LOSS WAS LOCATED WITHIN THE FREEZE-THAW ZONE AROUND THE PERIMETER OF THE PIER. ADDITIONAL AREAS OF STONE LOSS AND MINOR CRACKING WITHIN INDIVIDUAL STONES WAS PRESENT SURROUNDING THE WATERLINE AS WELL.

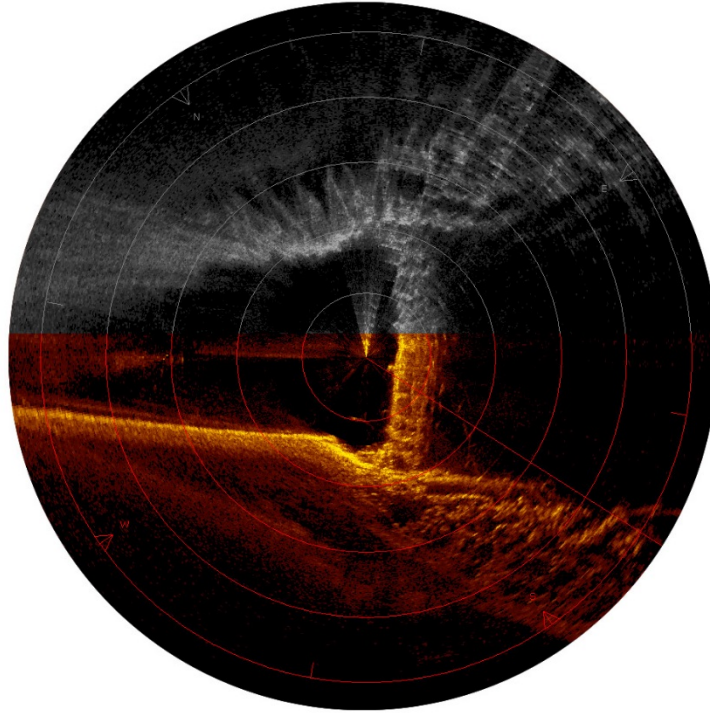
- Overall condition: Poor.
- Light weathering and freeze-thaw damage was noted on the masonry stone and the mortar joints surrounding the waterline.
- The water depth ranged from 12 feet to 20 feet surrounding the structure and dropped off significantly deeper downstream of the structure. Local scour was present starting at the upstream bullnose and continued around the entire pier.

Photo 5 – Pier 22 – Upstream bullnose, facing East  
Note: Scour starting in front of the bullnose

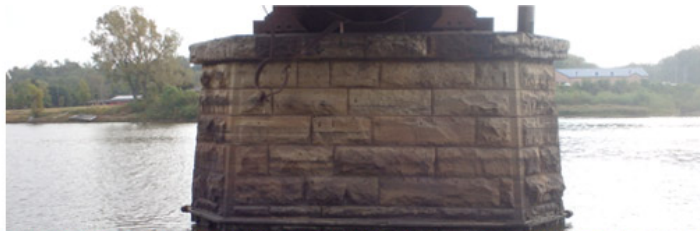
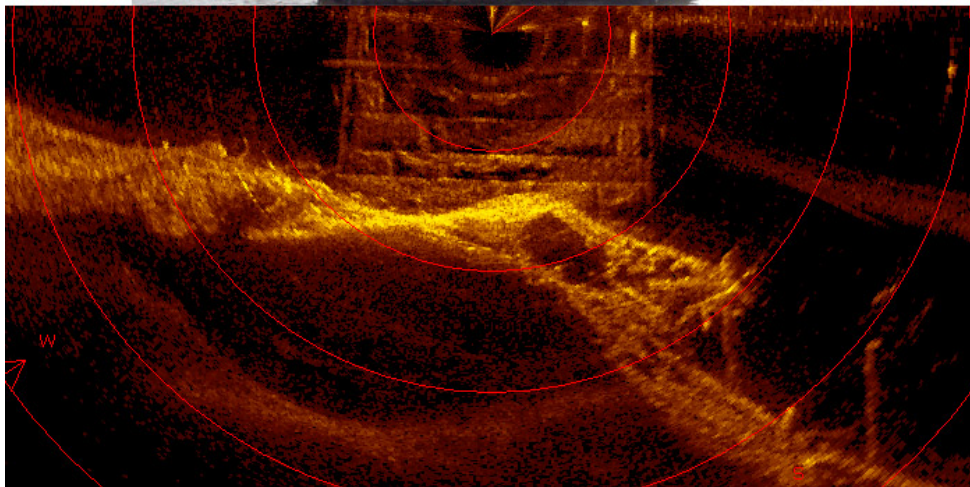
Photo 6 – Pier 22 – West face  
Note: Severe elevation change due to scour between upstream (left) and downstream (right)

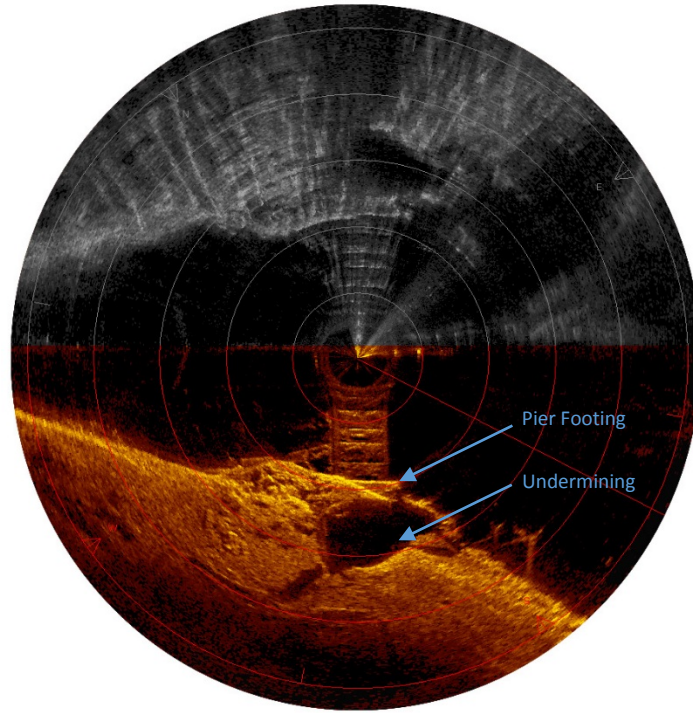
- Exposed timber cribbing and undermining were located along the downstream portions of the structure. The timber cribbing was found to be 15 feet wide along the downstream face of the structure and was located approximately 15 feet below the waterline. Undermining was present across the entire width of the cribbing foundation, extended four (4) feet up the West face of the pier, two (2) feet up the East face, and was four (4) feet tall beneath the cribbing at its deepest point. There were three (3) vertical timber piles exposed within the area of undermining.

Photo 7 – Pier 22 – Southwest bullnose face  
Note: Exposed footing and subsequent undermining void beneath

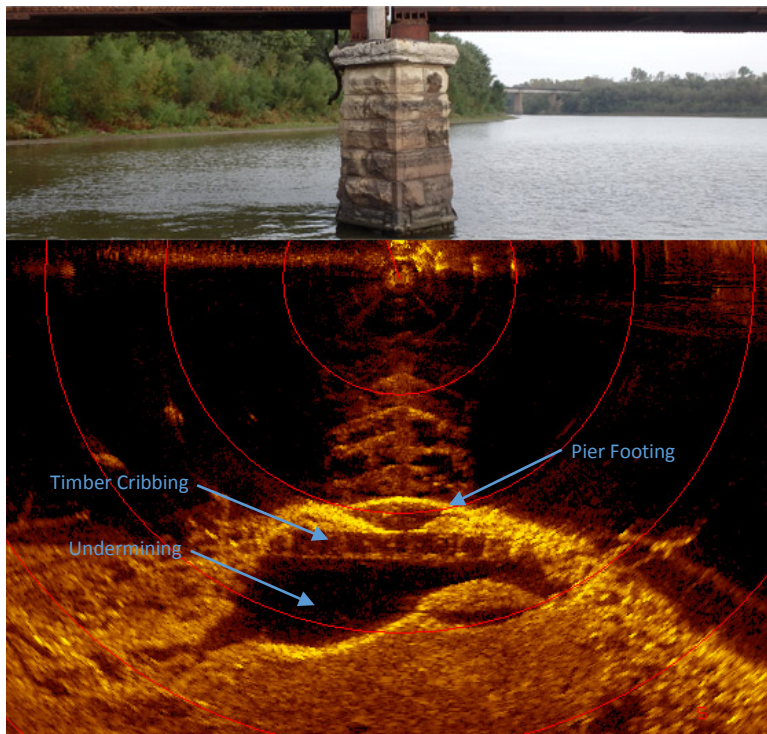
- The areas of exposed timber (cribbing and piles) appeared to be in sound condition. Sporadic penetration tests were conducted across the exposed areas of timber with an average penetration of approximately 1/8 inch.

Photo 8 – Pier 22 – South face  
Note: Exposed footing, timber cribbing, and subsequent undermining

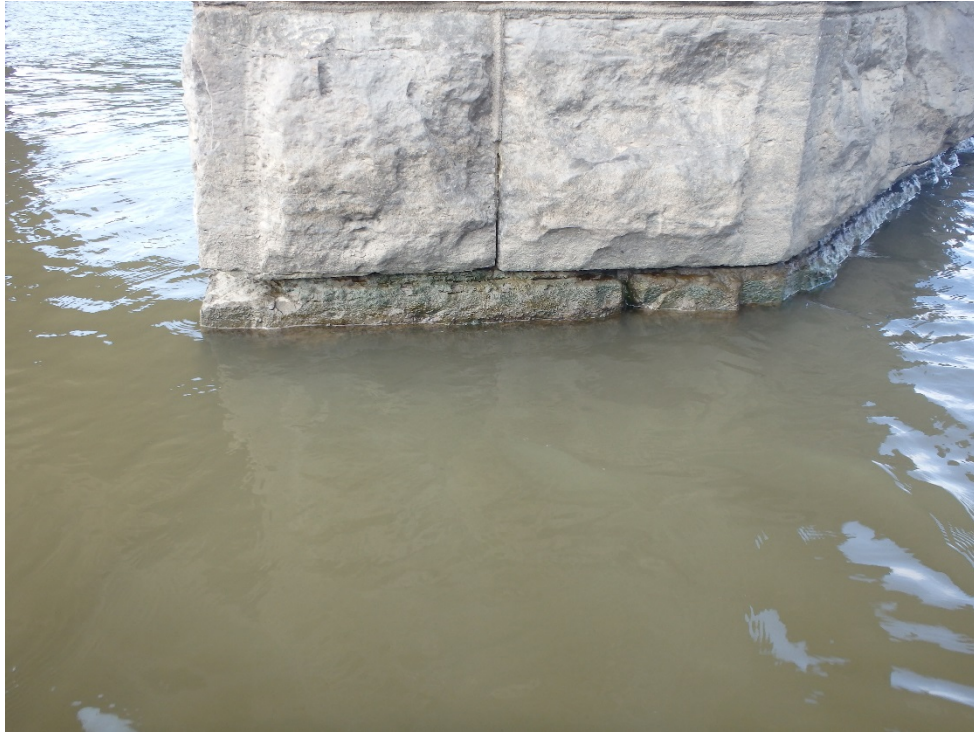
Photo 21 – Typical mortar joint loss within the freeze-thaw zone

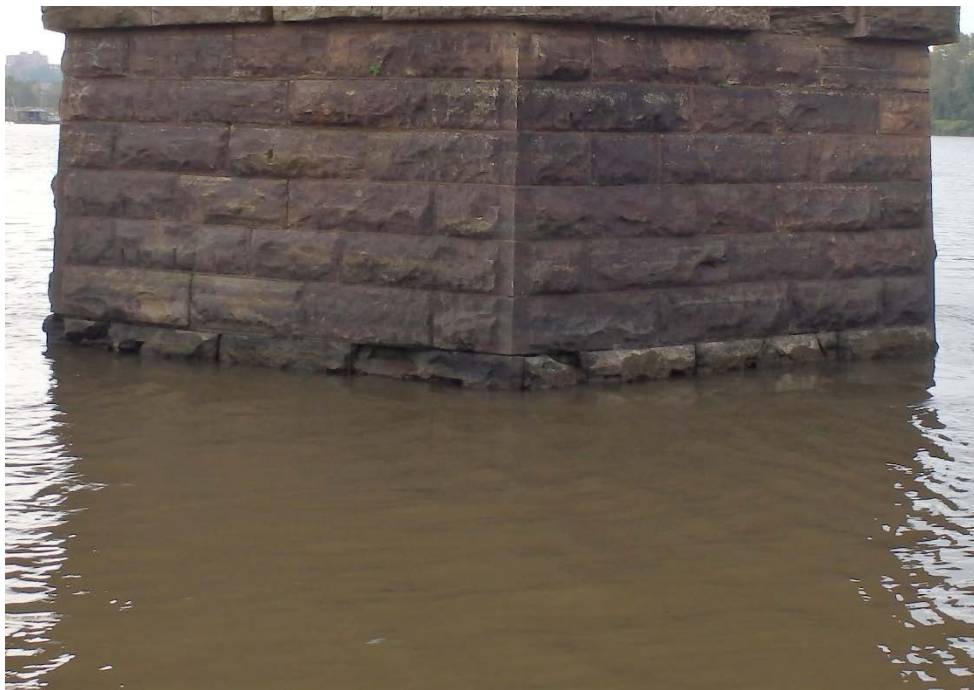
Photo 22 – Typical masonry stone loss and cracking surrounding the waterline
