# UNDERWATER INSPECTION REPORT

Quinsippi Island Bridge  
Over the Mississippi River  
Near Quincy, IL

Inspection Date: October 8, 2015

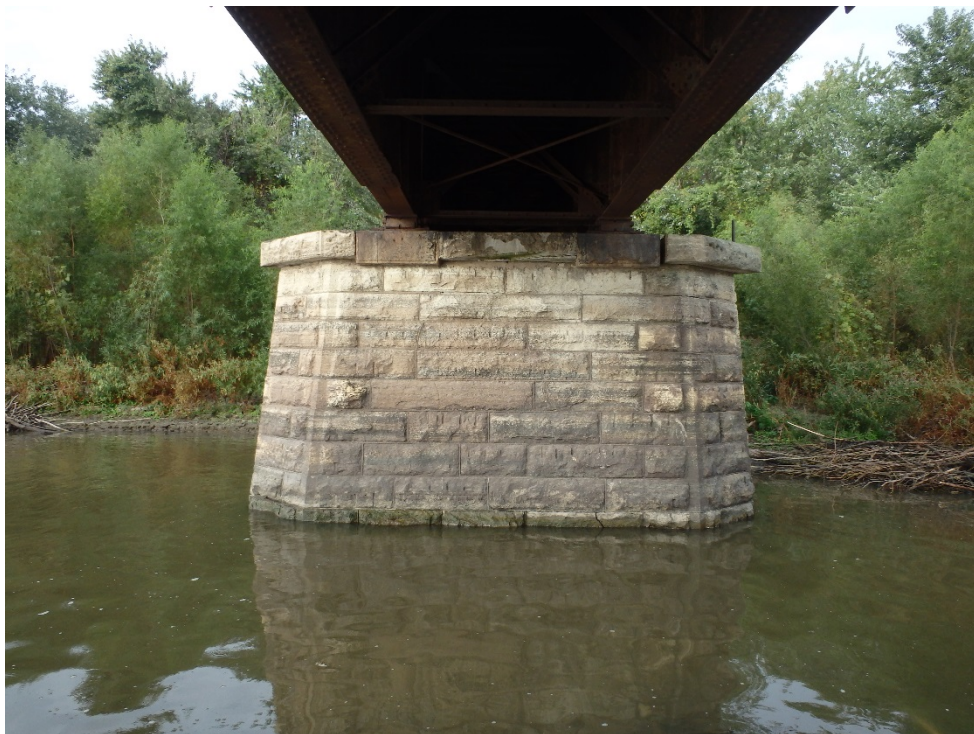
Photo 2 – Pier 21 – East face

- Overall condition: Satisfactory.
- The general condition of the pier had not significantly changed since the last inspection.
- Light weathering and freeze-thaw damage was noted on the masonry stone and the mortar joints surrounding the waterline.
- The water depth ranged from two (2) to five (5) feet surrounding the structure. The shallow depths prevented acoustic imaging of the structure.
- The bottom substrate consisted of very soft mud/silt. Minor timber drift accumulation was located around the upstream bullnose of the pier.
- Probing was conducted around the perimeter of the structure with no indication of the pier footing or any undermining.

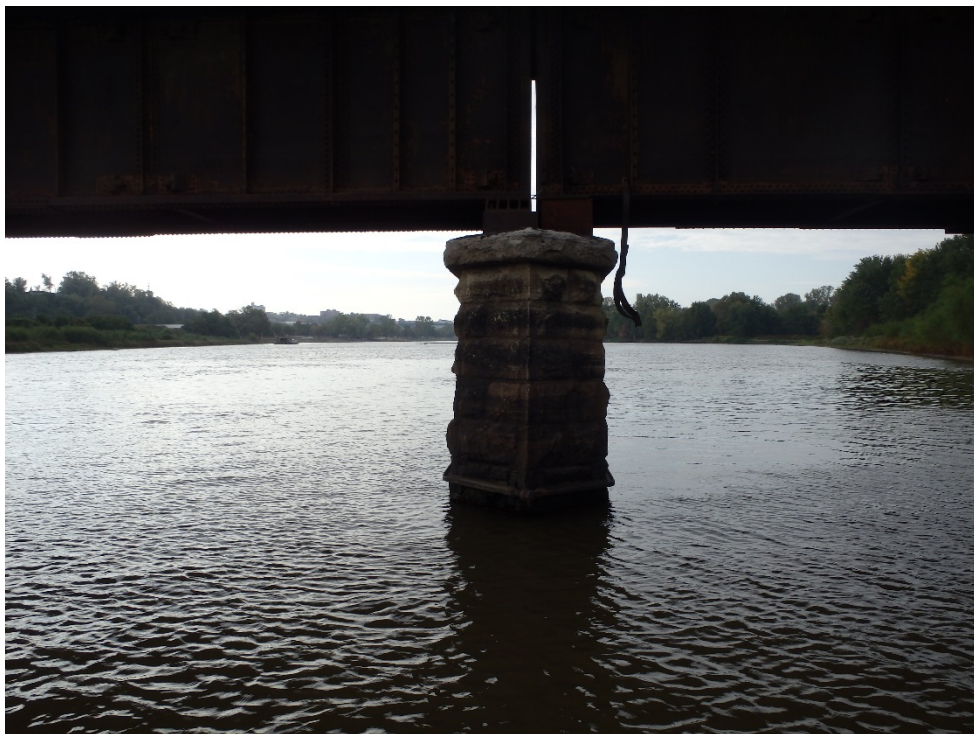
Photo 4 – Pier 22 – North face

- Overall condition: Poor.
- Light weathering and freeze-thaw damage was noted on the masonry stone and the mortar joints surrounding the waterline.
- The water depth ranged from 12 feet to 20 feet surrounding the structure and dropped off significantly deeper downstream of the structure. Local scour was present starting at the upstream bullnose and continued around the entire pier.

- Exposed timber cribbing and undermining were located along the downstream portions of the structure. The timber cribbing was found to be 15 feet wide along the downstream face of the structure and was located approximately 15 feet below the waterline. Undermining was present across the entire width of the cribbing foundation, extended four (4) feet up the West face of the pier, two (2) feet up the East face, and was four (4) feet tall beneath the cribbing at its deepest point. There were three (3) vertical timber piles exposed within the area of undermining.

- The areas of exposed timber (cribbing and piles) appeared to be in sound condition. Sporadic penetration tests were conducted across the exposed areas of timber with an average penetration of approximately 1/8 inch.

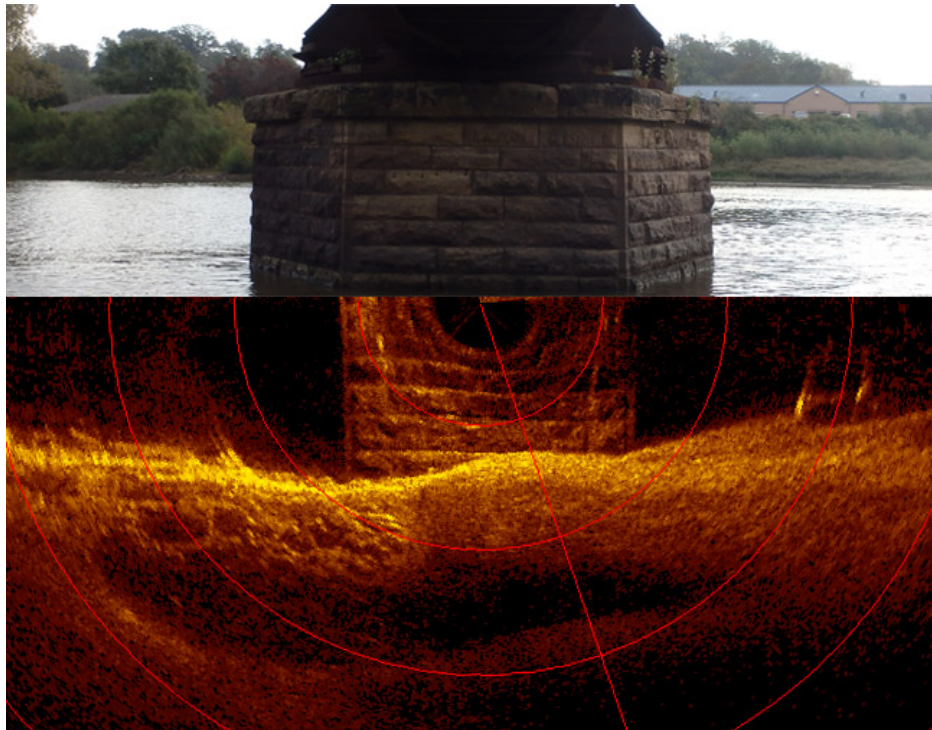
Photo 10 – Pier 23 – West face

- Overall condition: Satisfactory.
- The general condition of the pier had not significantly changed since the last inspection.
- Moderate weathering and freeze-thaw damage was noted on the masonry stone and the mortar joints surrounding the waterline. Typical pockets of stone loss measured approximately five (5) inches by five (5) inches and were up to two (2) inches deep. Cracking was evident in several of the masonry stones. The cracking also appeared to be a result from weathering / freeze-thaw rather than from settling / shear stress as the cracks were contained to individual stones and were not observed to extend across multiple courses of the stone structure.

- The water depth ranged from four (4) to 10 feet surrounding the structure.
- The bottom substrate was found to be primarily soft mud/silt. Accumulated areas of river rock or possible rip rap were found on the East side of the structure. Sporadic large stone debris was also located in the vicinity of the structure.

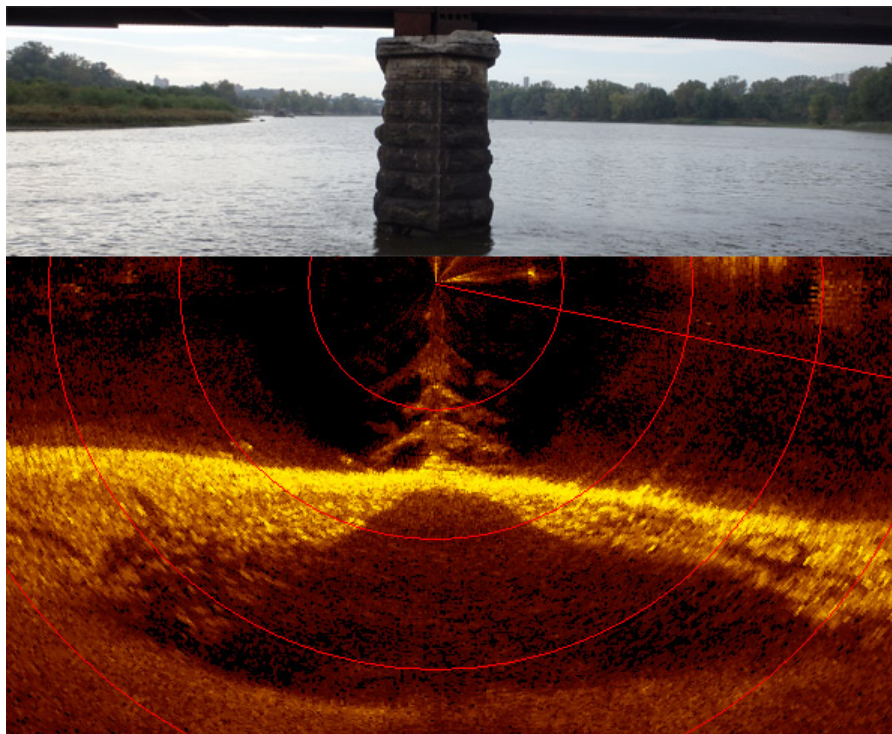
Photo 14 – Pier 24 – North face

- Overall condition: Satisfactory.
- The general condition of the pier had not significantly changed since the last inspection.
- Light weathering and freeze-thaw damage was noted on the masonry stone and the mortar joints surrounding the waterline. Additional light cracking was noted in several individual stones.
- The water depth was approximately 12 feet surrounding the structure.
- The bottom substrate consisted primarily of soft mud/silt. Minor timber drift accumulation was located around the upstream bullnose of the pier.
- Probing was conducted around the perimeter of the structure with no indication of the pier footing or any undermining.
